EID at work—maintaining the water lines 24/7 all year long

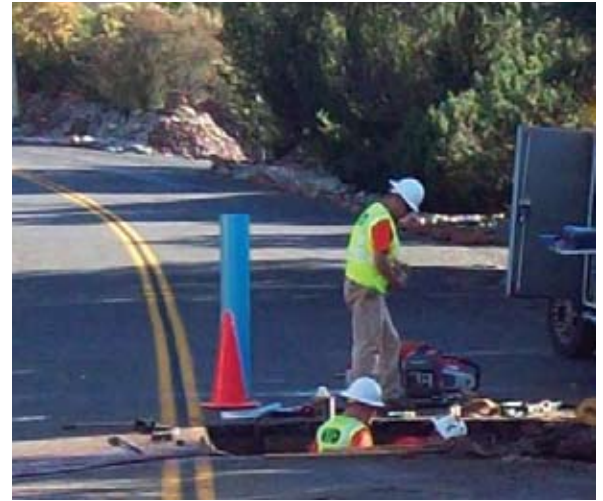
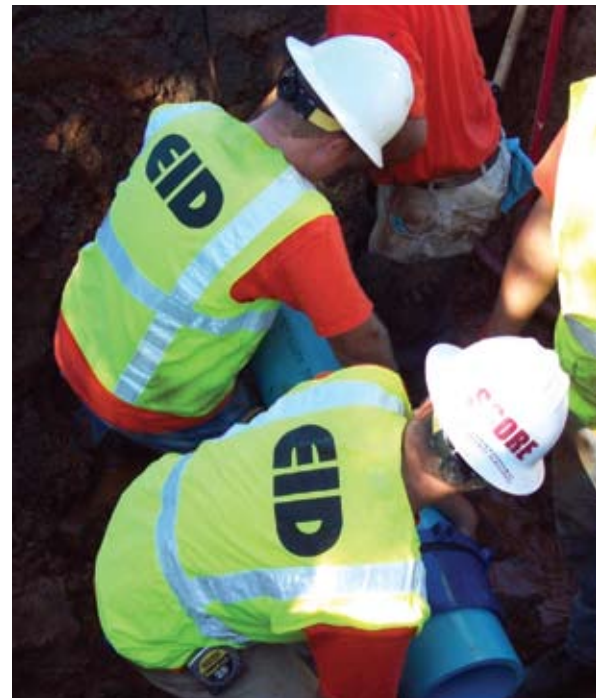
It's early—around 5:00 a.m.—on a late-September morning in Cameron Park when a rusted saddle on an 8-inch water main buried 4 feet underground gives way, forcing a pressurized stream of water up through the pavement 30 feet into the air on Sudbury Road near Valerio Drive.

Clay and Joel know exactly what to do. And by 5:45 a.m.—less than half an hour after Clay arrived on the scene—the water is off and the cause of the break is known. It's also clear that the rusted saddle, which connects the 8-inch main line to a 2-inch individual residential service line, must be replaced. As additional workers arrive, they immediately begin the repair. The reporter tells his audience that the team works fast.

By a little after noon, the repair is complete, and state-required water samples have been taken. Service to about 23 households is restored with virtually no property damage from the line break.
